HISTORIC PROPERTY INVENTORY FORM

Field Site No. 3790 **OAHP No.** **Date Recorded** 7 Nov 1994
Site Name Historic Safeguards and Security Building **Revised** 30 May 1997
Common
Field Recorder M.E. Crist, I.C. Lindsay, K.A. Simmons
Owner's Name U.S. Department of Energy, Richland Operations Office
Address P.O. Box 550
City/State/Zip Code Richland, WA 99352

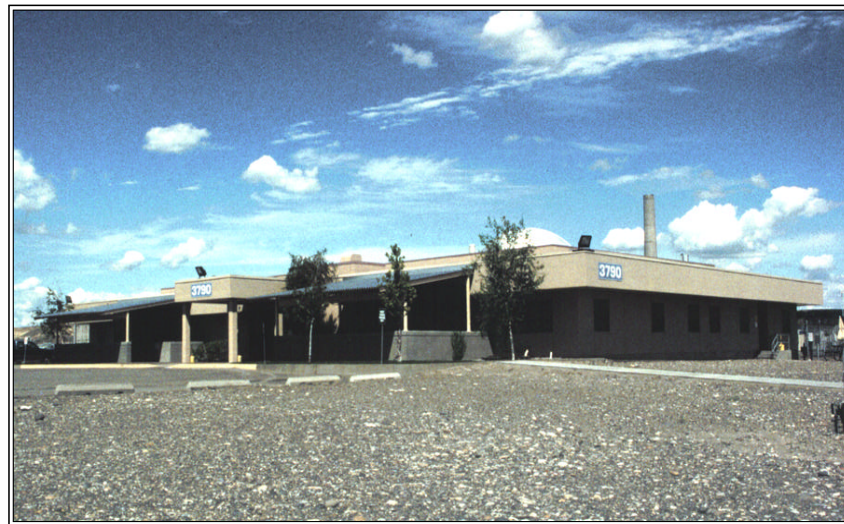
Photography HCRL
Photography Neg. No. Roll 177, frames 22-26
(Roll No. & Frame No.) Roll 276, frames 22-23
View of All exterior facades
Date 7 Nov 1994
Photo at right: Roll 276, frame 23
View of west and south facades

The 3790 Building is a single story, modified rectangular structure measuring 90 feet by 138 feet on a north-south axis. It has a raised foundation and a basement. The flat, metal deck roof has rigid insulation and built-up asphalt and gravel finish. A thick cornice surrounds the roof. Decorative, vertical grooves are symmetrically placed in aggregate surface of all the exterior walls, but not on most of the cornice. Double pane windows are present on all sides of the building. A single door entrance is recessed in the south wall. On the east wall, double pane windows run symmetrically along the length of the building. On the north wall, there is a recessed single entry door on the west end with a ramp leading to it. A double glass door entrance within a portico is located near the center of the west wall. The basement level can be accessed by concrete stairwells on either side of the portico. At ground level, short concrete boundaries inlaid with aggregate shield the stairwells. On the north wall is another recessed entry door. The interior walls on the main floor are bolted steel framework with gypsum sheeting. In 1991, the basement was modified to accommodate 18 offices, and the bare concrete floors were carpeted as part of its conversion to house Safeguards and Security.
